**Flood Control Project Maintenance
Levee Inspections**
LMA District Cover Sheet
Spring 2016 Levee Inspection Results

Reclamation District No. 0017 Mossdale

Spring 2016 Levee Inspection Results

Waterway			Bank	Unit Miles
Unit No. 01 French Camp Slough			Left	1.76
	Spring (March - May)	Summer (June - August)	(September - November) Fall	Winter (December - February)
Unit Maintenance Rating (Fall Only)				
Date of Inspection	4/5/2016 - 4/5/2016			
DWR Inspector	Richard Willoughby			
Accompanied By	Robert Winter KSN

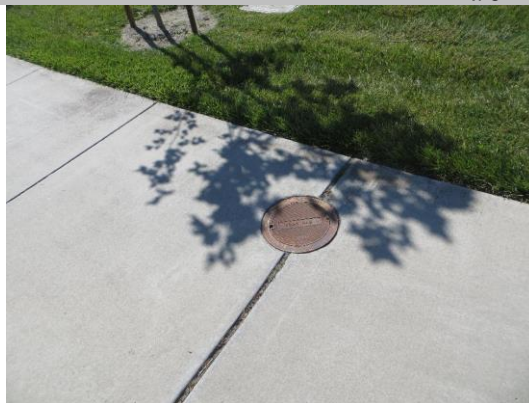
Photo 1 of 2 : UCIP_SP_2016_46010_74222.jpg

FS_ID:46010
DS_ID:72
EP_NO: 15185
Repair Type: Urgent
Crossing Status: Indicator Found
UCIP Comments: Need to install gasoline markers.
FIELD_STRUCT_DESC: 8-inch-diameter soil proofed steel gas main through the left bank levee and under the channel of French Camp Slough. The pipeline has a minimum cover of 5 feet within the overflow areas and under the channel. (Permit No. 15185-1989)
FS Date: 5/19/2015

LM Start	0.15	Rating **	U	Issue No.	17 (cont)
LM End	0.15	Issue Type +	En	Location *	LS

Gas access lid in sidewalk Approximately 200-feet to west of crown.

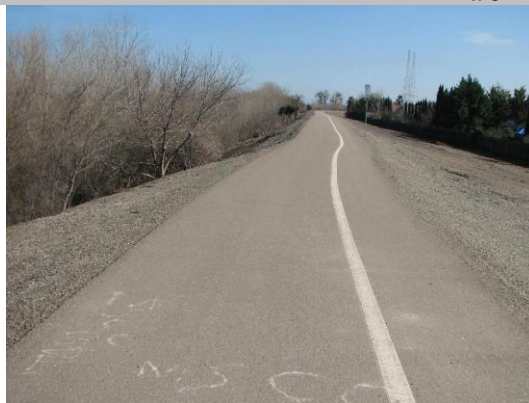
Photo 1 of 2 : UCIP_SP_2016_40604_38491.jpg

FS_ID:40604
DS_ID:2
EP_NO: 14992
Repair Type: Non-Urgent
Crossing Status: Indicator Found
UCIP Comments: Need to contact owner to determine status of crossing. Also need date of last inspection.
FIELD_STRUCT_DESC: 1 of 3. 30-inch diameter HDPE sewer force main (SFM). All pipes encased in concrete at approximately 32 feet below levee crown. (Permit No. 14992-1989)
FS Date: 2/3/2010

LM Start	1.31	Rating **	M	Issue No.	14 (cont)
LM End	1.31	Issue Type +	En	Location *	WS

Overview of levee crown at crossing.

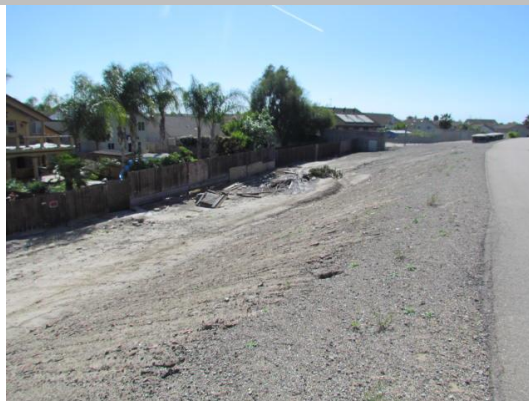
Photo 1 of 2 : SP_2016_RD0017_304_77_20160408_00194.jpg

LM Start	0.77	Rating **	M	Issue No.	77 (cont)
LM End	0.77	Issue Type +	Ma	Location *	LS

Looking east at pruning at landward toe.

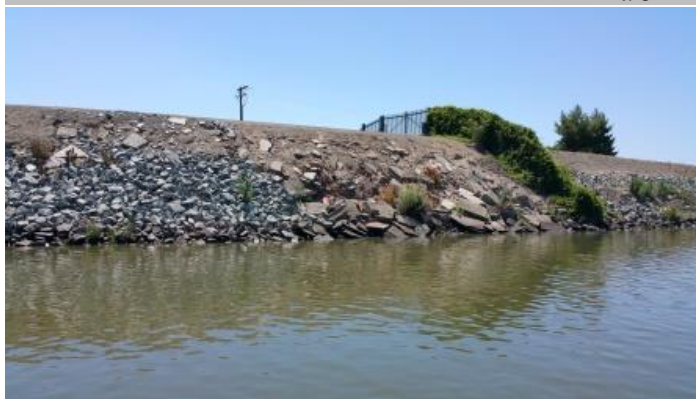
Photo 1 of 2 : SP_2016_RD0017_304_2_20160404_00004.jpg

LM Start	1.08	Rating **	U	Issue No.	2
LM End	1.08	Issue Type +	Ma	Location *	WS
Category	Supplemental			GPS Latitude/Longitude	
				Start	End
Item	DWR Erosion Survey			37.902530 °	37.902530 °
				-121.325690 °	-121.325690 °
DWR ID	DWR_RD0017_02_s_2016_2				
Comment Code					
Inspector Comment					
06/24/2015: No significant change observed. 6/19/2014: No significant change observed. 08/13/2013: No significant change at this site. 08/07/2012: The erosion is nearly vertical, and has developed upward to halfway of the levee slope. The protecting concrete blocks have been washed away. Animal activities are visible. [2015 Site ID:RD0017U02RM44.32]

Front view of the erosion site. Note the concrete blocks and vegetation.

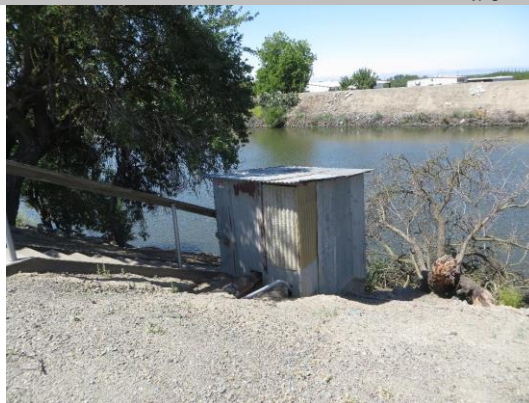
Photo 1 of 2 : UCIP_SP_2016_45959_74428.jpg

Comment Code					
Inspector Comment					
FS_ID:45959 DS_ID:8 EP_NO: 15097 Repair Type: Urgent Crossing Status: Found UCIP Comments: 05/19/15 Hole located on landward toe is still present and covered by dense vegetation. Hole is approximately 6 feet in diameter. 02/10/10 Exposed section of levee on landward side--sink hole located at landward toe. Need to contact owner and DWR inspector to address issue. FIELD_STRUCT_DESC: 8-inch diameter irrigation pipeline through levee. Invert of pipe is 4.0 feet below levee crown. Pump house is located on the waterward slope. Siphon breaker on landward shoulder, standpipe located 10 feet from landward tee. Concrete stairs on waterward slope. (Permit No. 15097-1990) FS Date: 5/19/2015

LM Start	1.16	Rating **	U	Issue No.	614 (cont)
LM End	1.16	Issue Type +	En	Location *	WS

(2015) View of waterward side.

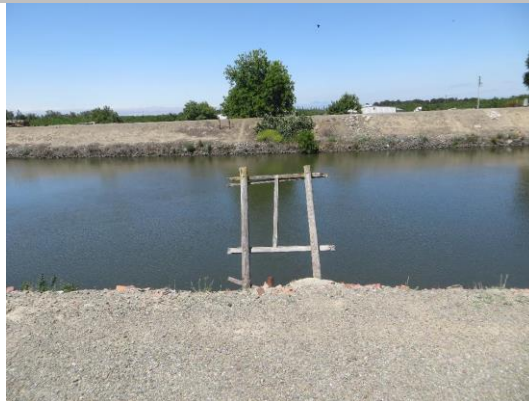
Photo 1 of 2 : UCIP_SP_2016_45449_74105.jpg

FS_ID:45449
DS_ID:9
EP_NO: N/A
Repair Type: Non-Urgent
Crossing Status: Indicator Found
UCIP Comments: Appears abandoned. Should contact owner to determine status as signs have been removed from supports and should be replaced if still in service.
FIELD_STRUCT_DESC: Underground telephone cable through levee, 2 feet below crown. Warning signs on waterward slope.
FS Date: 5/19/2015

Sign on WS slope.

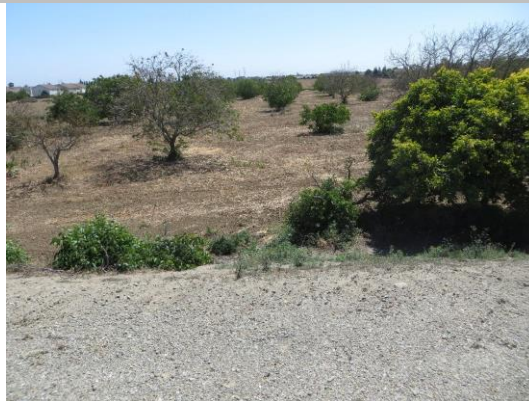
Photo 2 of 2 : UCIP_SP_2016_45449_74104.jpg

No markers on LS.

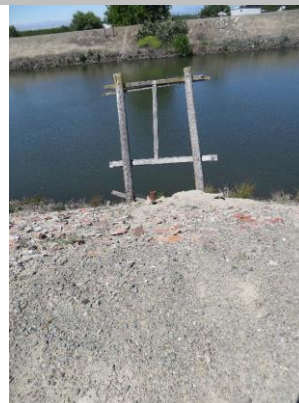
Photo 1 of 2 : UCIP_SP_2016_45450_74107.jpg

LM Start	1.18	Rating **	M	Issue No.	628
LM End	1.18	Issue Type +	En	Location *	WS
Category	Supplemental			GPS Latitude/Longitude	
				Start	End
Item	DWR UCIP Field Study			37.901012 °	37.901012 °
				-121.325497 °	-121.325497 °
DWR ID					
Comment Code					
Inspector Comment					
FS_ID:45450					
DS_ID:308					
EP_NO: N/A					
Repair Type: Non-Urgent					
Crossing Status: Indicator Found					
UCIP Comments: Appears Abandoned. Need to contact owner to determine status of crossing as signs have been removed from markers and should be replaced if still in service.					
FIELD_STRUCT_DESC: 4-inch submarine telephone cable through the levee, 2.0 feet below the crown, and across the channel. Location marker on the waterward slope.					
FS Date: 5/19/2015

Sign post on WS slope.

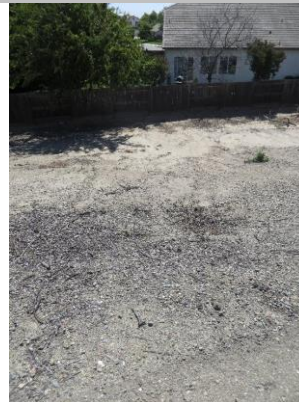
Photo 2 of 2 : UCIP_SP_2016_45451_74108.jpg

View of LS. No appurtenances noted.

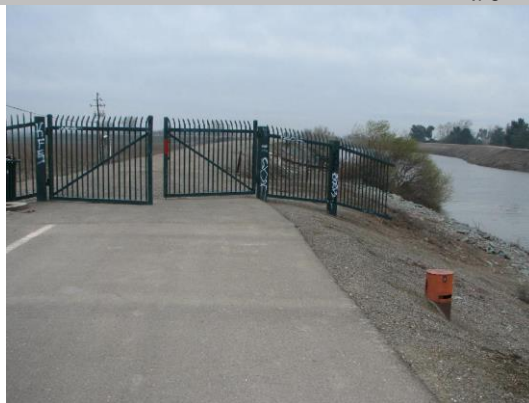
Photo 1 of 2 : UCIP_SP_2016_40639_38687.jpg

LM Start	1.45	Rating **	M	Issue No.	601
LM End	1.45	Issue Type +	En	Location *	WS
Category	Supplemental			GPS Latitude/Longitude	
				Start	End
Item	DWR UCIP Field Study			37.897280 °	37.897280 °
				-121.326775 °	-121.326775 °
DWR ID					
Comment Code					
Inspector Comment					
FS_ID:40639					
DS_ID:11					
EP_NO: 15316					
Repair Type: Non-Urgent					
Crossing Status: Indicator Found					
UCIP Comments: Need to contact owner to determine status--pipe was not found only siphon breaker housing unit.					
FIELD_STRUCT_DESC: 8 inch diameter discharge pipeline through levee. Invert of pipe is 3.8 feet below levee crown. Siphon breaker on the waterward shoulder. Pump is located inside ditch located approximately 75 feet landward of levee toe. (Permit No. 15316-1989)					
FS Date: 2/4/2010

View of levee crown at crossing.

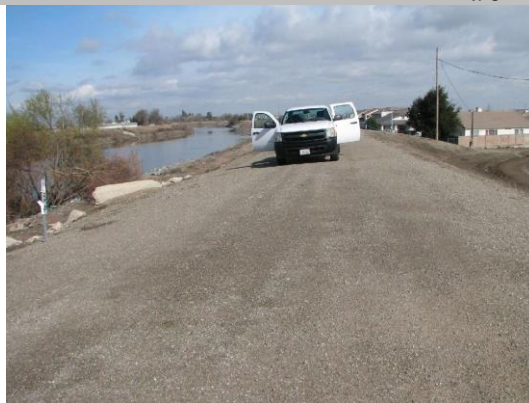
Photo 1 of 2 : UCIP_SP_2016_40640_71981.jpg

LM Start	1.50	Rating **	M	Issue No.	602
LM End	1.50	Issue Type +	En	Location *	WS
Category	Supplemental			GPS Latitude/Longitude	
				Start	End
Item	DWR UCIP Field Study			37.896602 °	37.896602 °
				-121.327104 °	-121.327104 °
DWR ID					
Comment Code					
Inspector Comment					
FS_ID:40640					
DS_ID:12					
EP_NO: 15099					
Repair Type: Non-Urgent					
Crossing Status: Found					
UCIP Comments: Need to coordinate with owner to determine status of crossing. If crossing is no longer in use owner will need to contact the CVFPB to comply with Title 23.					
FIELD_STRUCT_DESC: 16 inch diameter irrigation pipeline through levee. Invert of pipe is 3.64 feet below levee crown. Siphon breaker on waterward shoulder. Pump house located on the waterward berm. Standpipe located 15 feet from landward toe. Concrete stairway on waterward slope. (Permit No. 15099-1989)					
FS Date: 2/4/2010

View of levee crown at crossing.

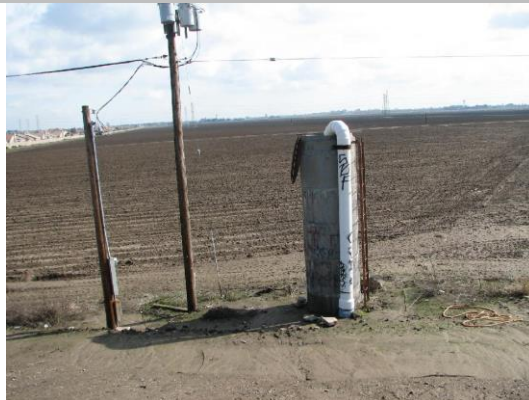
Photo 2 of 2 : UCIP_SP_2016_40640_38706.jpg

Standpipe located on landward side.

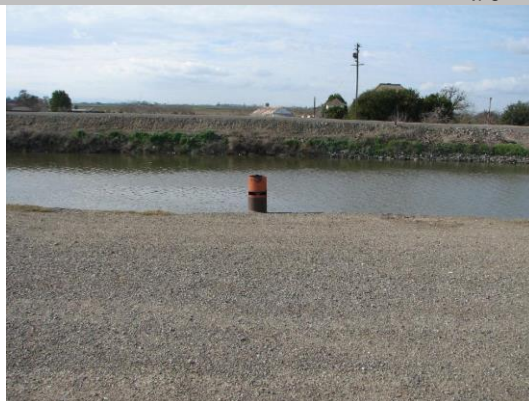
Photo 1 of 2 : UCIP_SP_2016_40642_38742.jpg

Comment Code					
Inspector Comment					
FS_ID:40642					
DS_ID:14					
EP_NO: 15317					
Repair Type: Non-Urgent					
Crossing Status: Found					
UCIP Comments: Need to coordinate with owner to determine status of crossing. Need to find out if pipe located on landward side is tied to pipe through levee. Pipe found on waterward side is filled with concrete (non-functional).					
FIELD_STRUCT_DESC: 10 inch diameter steel stormwater discharge pipeline through levee. Invert of pipe is 4.74 feet below levee crown. Siphon breaker on waterward slope. Pump in ditch located 300 feet landward of toe. Ramp on landward slope. 10 inch pipe connects to an existing 16 inch discharge pipe on the landward side. (Permit No. 15317-1990) This pipe was installed during the levee work approved under encroachment number 15014.					
FS Date: 2/4/2010

View of waterward side--riser located on waterward shoulder.

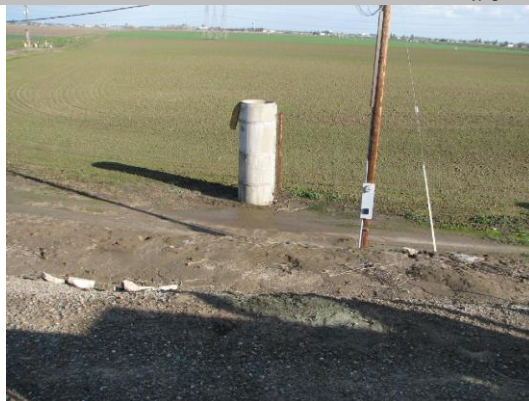
Photo 1 of 2 : UCIP_SP_2016_42875_38770.jpg

Comment Code					
Inspector Comment					
FS_ID:42875					
DS_ID:15					
EP_NO: 15101					
Repair Type: Urgent					
Crossing Status: Found					
UCIP Comments: Sink hole present at siphon breaker riser located on waterward shoulder. Need to coordinate with owner to determine status of crossing. If crossing is no longer in use owner will need to contact the CVFPB to comply with Title 23.					
FIELD_STRUCT_DESC: 16 inch diameter pipeline through levee. Invert of pipe is 4.26 feet below levee crown. Siphon breaker on waterward shoulder. Pump house located on the waterward berm, standpipe located 25 feet from landward toe. Concrete stairway on waterward slope. (Permit No. 15101-1989)					
FS Date: 2/4/2010

View of landward side.

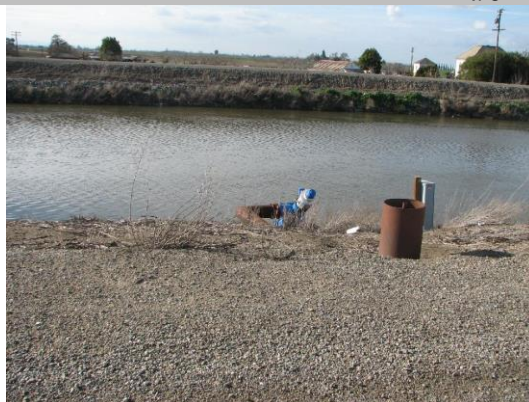
Photo 2 of 2 : UCIP_SP_2016_42875_38773.jpg

LM Start	2.05	Rating **	U	Issue No.	570 (cont)
LM End	2.05	Issue Type +	En	Location *	WS

View of waterward side.

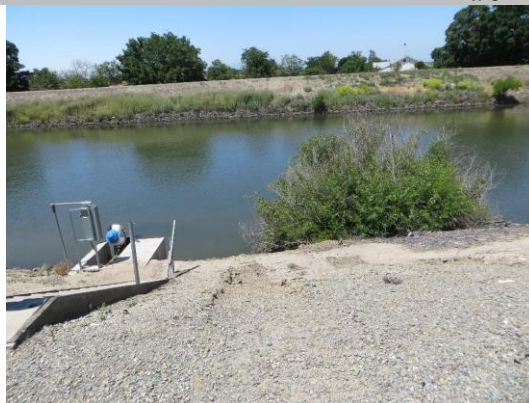
Photo 1 of 2 : UCIP_SP_2016_46009_74439.jpg

LM Start	2.66	Rating **	M	Issue No.	622 (cont)
LM End	2.66	Issue Type +	En	Location *	WS

(2015) View of waterward slope.

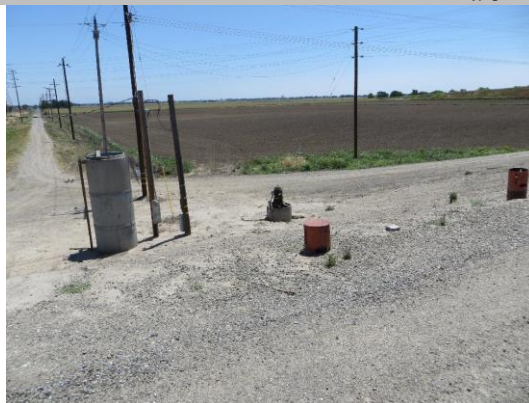
Photo 1 of 2 : UCIP_SP_2016_46003_74448.jpg

LM Start	2.67	Rating **	U	Issue No.	617 (cont)
LM End	2.67	Issue Type +	En	Location *	WS

(2015) View of landward side.

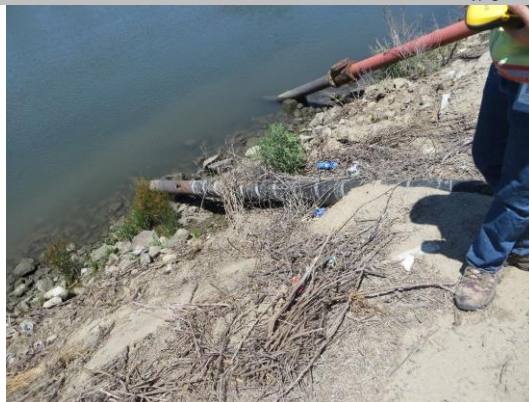
Photo 2 of 2 : UCIP_SP_2016_46003_74449.jpg

(2015) Pipe exposed without coating indicates holes through pipe wall.

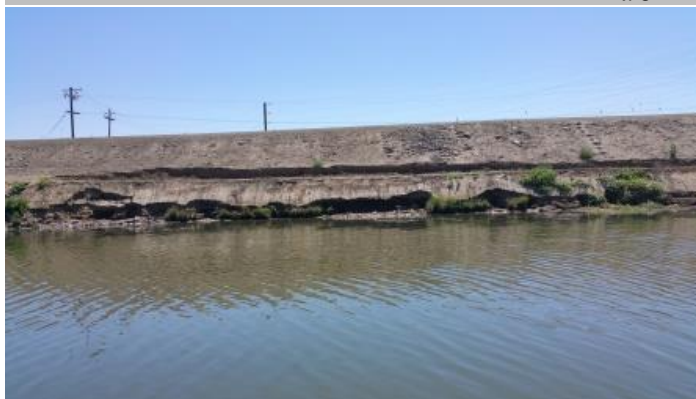
Photo 1 of 2 : SP_2016_RD0017_304_6_20160404_00006.jpg

LM Start	2.67	Rating **	M	Issue No.	6 (cont)
LM End	2.69	Issue Type +	Ma	Location *	WS

Front view of the erosion site. Note the new cut at the middle levee slope.

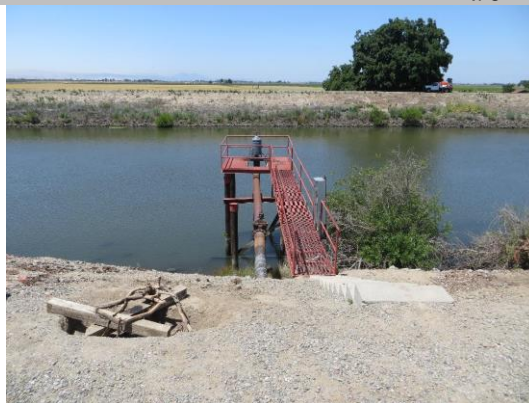
Photo 1 of 2 : UCIP_SP_2016_46004_74453.jpg

LM Start	2.76	Rating **	U	Issue No.	618 (cont)
LM End	2.76	Issue Type +	En	Location *	WS

(2015) View of waterward side--pit filled with wood debris will need to be filled and cleared.

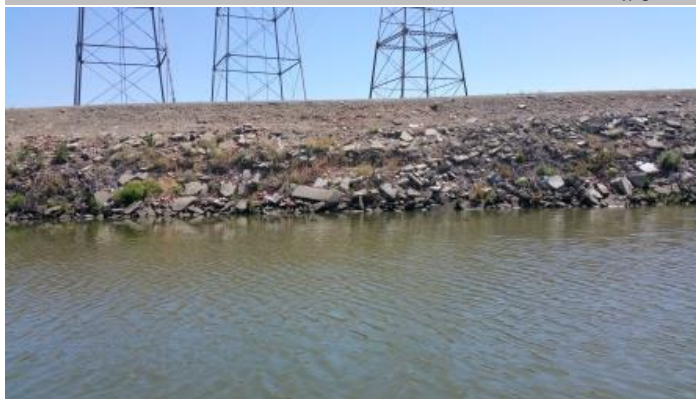
Photo 1 of 2 : SP_2016_RD0017_304_8_20160404_00008.jpg

LM Start	2.82	Rating **	M	Issue No.	8 (cont)
LM End	2.82	Issue Type +	Ma	Location *	WS

Front view of the erosion.

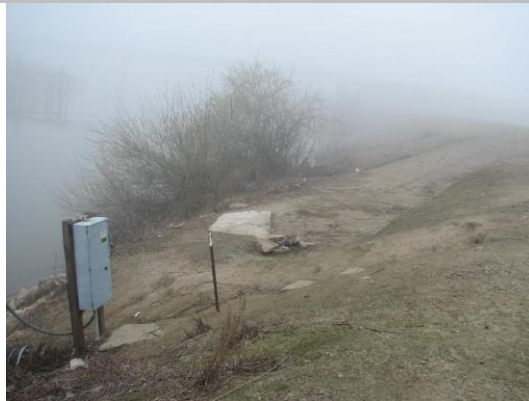
Photo 1 of 2 : UCIP_SP_2016_40655_72050.jpg

LM Start	3.00	Rating **	M	Issue No.	579 (cont)
LM End	3.00	Issue Type +	En	Location *	WS

View of waterward side.

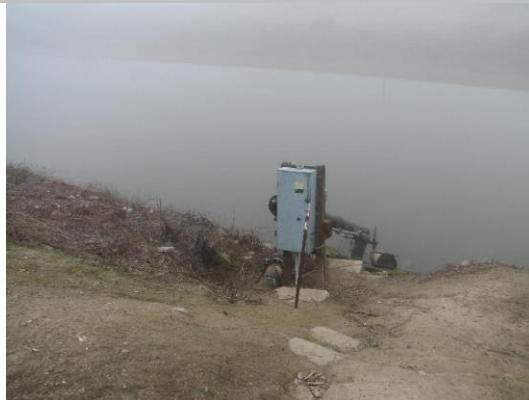
Photo 2 of 2 : UCIP_SP_2016_40655_72051.jpg

Pump station and control panel located on waterward side.

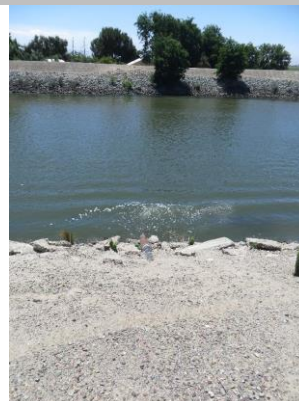
Photo 1 of 2 : UCIP_SP_2016_46005_74456.jpg

Comment Code					
Inspector Comment					
FS_ID:46005 DS_ID:21 EP_NO: 15310 Repair Type: Non-Urgent Crossing Status: Found UCIP Comments: 05/19/15 Deteriorated section of pipe has been replaced. Need to contact KSN, engineering consulting representing LMA, to determine repair details and to obtain permit authorizing repair.02/04/10 Pipe wall deteriorated. Need to coordinate with owner to determine status of crossing. If crossing is no longer in use owner will need to contact the CVFPB to comply with Title 23. FIELD_STRUCT_DESC: 10 inch discharge pipeline through levee. The invert of the pipe is 3.78 feet below crown. Siphon breaker on landward shoulder. Pump located on the landward side approximately 45 feet from the levee toe. (Permit No. 15310-1989) This pipe was installed during the levee work approved under encroachment number 15014. FS Date: 5/19/2015

(2015) View of waterward side.

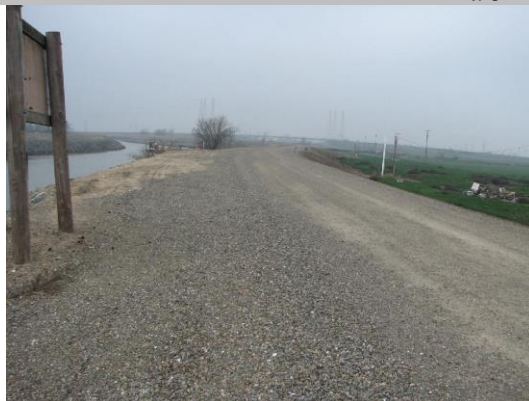
Photo 1 of 2 : UCIP_SP_2016_40658_72112.jpg

LM Start	3.47	Rating **	M	Issue No.	580 (cont)
LM End	3.47	Issue Type +	En	Location *	WS

View of levee crown at crossing.

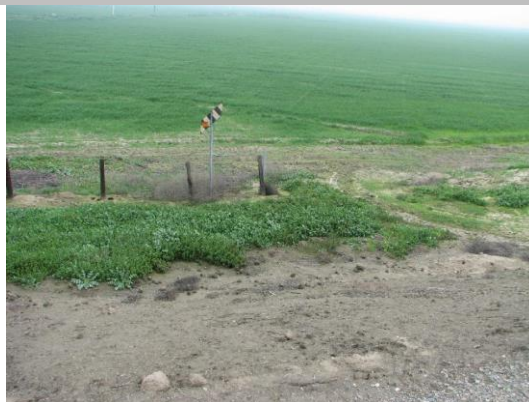
Photo 2 of 2 : UCIP_SP_2016_40658_72111.jpg

View of landward side.

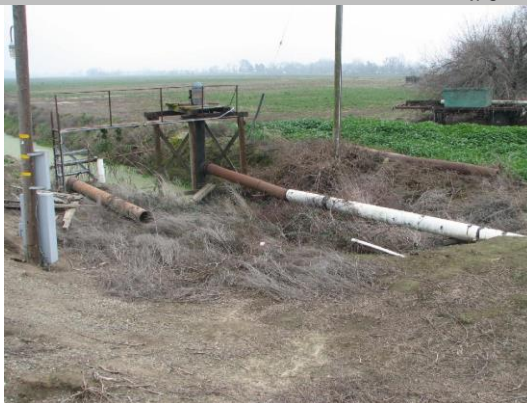
Photo 1 of 2 : UCIP_SP_2016_40659_72116.jpg

LM Start	3.63	Rating **	M	Issue No.	581 (cont)
LM End	3.63	Issue Type +	En	Location *	WS

View of pipe section and pump station located on landward side.

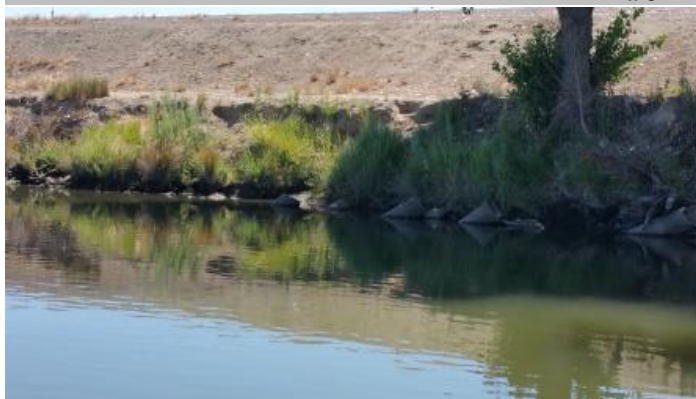
Photo 1 of 2 : SP_2016_RD0017_304_10_20160404_00011.jpg

LM Start	3.63	Rating **	M	Issue No.	10 (cont)
LM End	3.63	Issue Type +	Ma	Location *	WS

Front view of the erosion. Note the tree and the irrigation pipe.

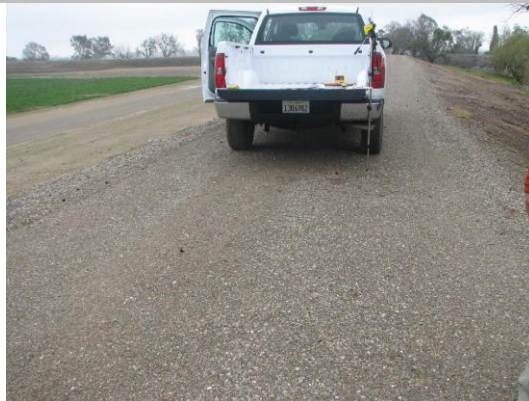
Photo 1 of 2 : UCIP_SP_2016_40660_72120.jpg

LM Start	3.73	Rating **	M	Issue No.	582
LM End	3.73	Issue Type +	En	Location *	WS
Category	Supplemental			GPS Latitude/Longitude	
				Start	End
Item	DWR UCIP Field Study			37.867247 °	37.867247 °
				-121.326724 °	-121.326724 °
DWR ID					
Comment Code					
Inspector Comment					
FS_ID:40660 DS_ID:27 EP_NO: 15110 Repair Type: Non-Urgent Crossing Status: Found UCIP Comments: Need to coordinate with owner to determine status of crossing. If crossing is no longer in use owner will need to contact the CVFPB to comply with Title 23. FIELD_STRUCT_DESC: 12 inch diameter irrigation pipeline through levee. Invert of pipe is 3.88 below levee crown. Siphon breaker on landward shoulder. Pump on landward slope, standpipe located 10 feet from the landward toe stairway. (Permit No. 15110-1989) FS Date: 2/4/2010

View of levee crown at crossing.

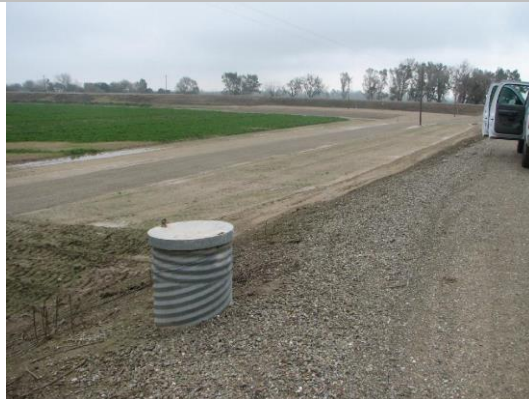
Photo 2 of 2 : UCIP_SP_2016_40660_72119.jpg

LM Start	3.73	Rating **	M	Issue No.	582 (cont)
LM End	3.73	Issue Type +	En	Location *	WS

Seepage berm located on landward side.

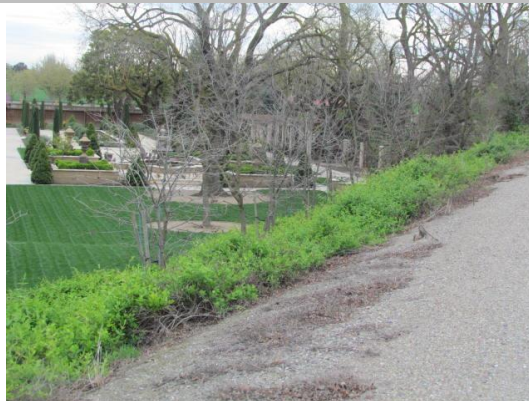
Photo 1 of 3 : SP_2016_RD0017_304_48_20160404_00014.jpg

LM Start	4.19	Rating **	A/W	Issue No.	48 (cont)
LM End	4.22	Issue Type +	En	Location *	LS

Looking southeast at dense ground cover on landside slope. (Spring 2013)

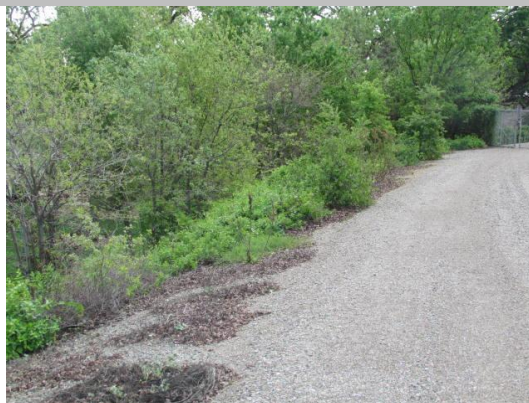
Photo 2 of 3 : SP_2016_RD0017_304_48_20160404_00015.jpg

Looking southeast at overgrown landscaping on landside slope. (Spring 2014)

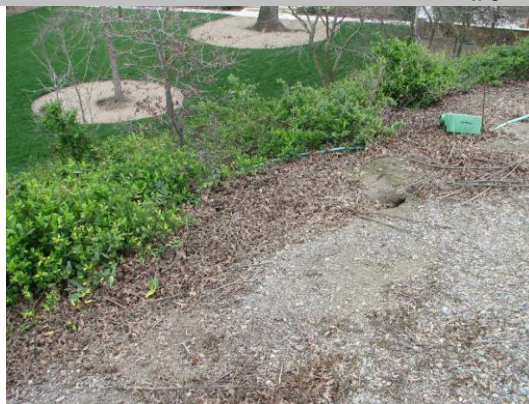
Photo 2 of 2 : UCIP_SP_2016_43264_72124.jpg

FS_ID:43264
DS_ID:28
EP_NO: 15111
Repair Type: Non-Urgent
Crossing Status: Found
UCIP Comments: 2/4/15--Olivia 2010 Records from KSN show this crossing was removed based on the RD17 As-Built Pipe Crossing Statining Reference, however when field verification was completed in this area a 2-inch pipe was found. This could be a different 2-inch pipe in nearby area. Need to coordinate with owner to determine permit issued for this crossing. 2/4/10 Pipe is not continous. Need to coordinate with owner to determine status of crossing. If crossing is no longer in use owner will need to contact the CVFPB to comply with Title 23.
FIELD_STRUCT_DESC: 2 inch pipeline through levee. Invert of pipeline is 3.92 feet below levee crown. Siphon breaker on landward shoulder. Pump on waterward slope. Pipe extends beyond 10 feet of the landward toe. (Permit No. 15111-1990). This pipe was installed during the levee work approved under encroachment number 15014.

View of landward side.

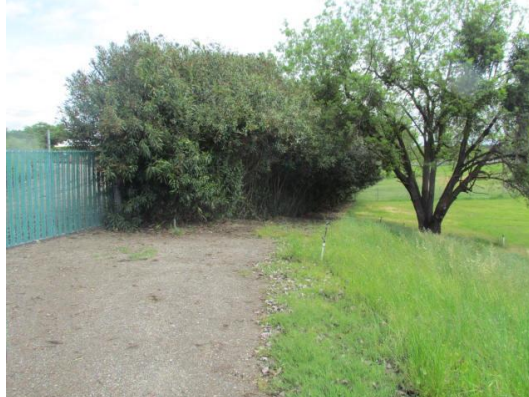
Photo 2 of 3 : SP_2016_RD0017_304_1_20160404_00002.jpg

LM Start	4.37	Rating **	M	Issue No.	1 (cont)
LM End	4.39	Issue Type +	En	Location *	LS

Looking south at overgrown oleanders on landside shoulder. (Spring 2014)

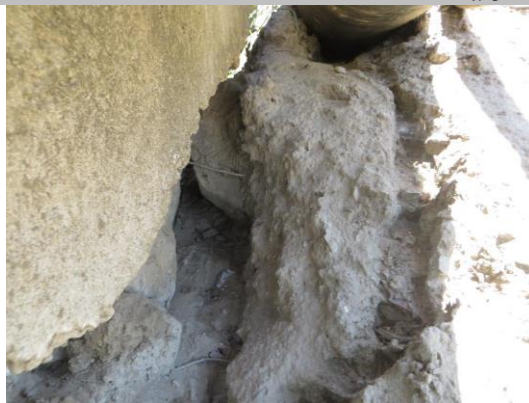
Photo 1 of 2 : UCIP_SP_2016_46007_74462.jpg

FS_ID:46007
DS_ID:33
EP_NO: 15116
Repair Type: Urgent
Crossing Status: Found
UCIP Comments: 05/19/2015 Signs of internal erosion visible on waterward side where pipe daylights. Slope slumping visible on landward side where previous levee damage was present. Need to contact owner and KSN, LMA engineering firm, to coordinate potential issues with pipe. 02/04/2010 Pipe failure--internal erosion visible on waterward and landward side. Recommend LMA superintendent notify owner to stop using crossing to avoid further damage to levee slope. Owner will need to coordinate with DWR Inspector and CVFPB to address pipe failure per Title 23 requirements.
FIELD_STRUCT_DESC: 14 inch diameter pipe through levee. Invert pipe is 4.83 feet below levee crown. Siphon breaker on waterward shoulder. Pump on platform in channel, wooden walkway extends from pump platform to waterward slope, concrete stairway extends from walkway to waterward shoulder. A double side approach ramp is located on the landward slope. Concrete stairway on waterward slope. (Permit No. 15116-1990) This pipe was installed during the levee work approved under encroachment number 15014.

LM Start	4.80	Rating **	U	Issue No.	620 (cont)
LM End	4.80	Issue Type +	En	Location *	LS

(2015) View of waterward side--signs of internal erosion along pipe alignment.

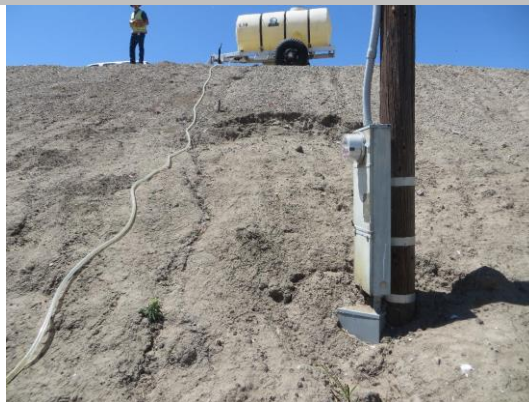
Photo 2 of 2 : UCIP_SP_2016_46007_74463.jpg

(2015) View of landward side--slope slumping at previous damage levee section.

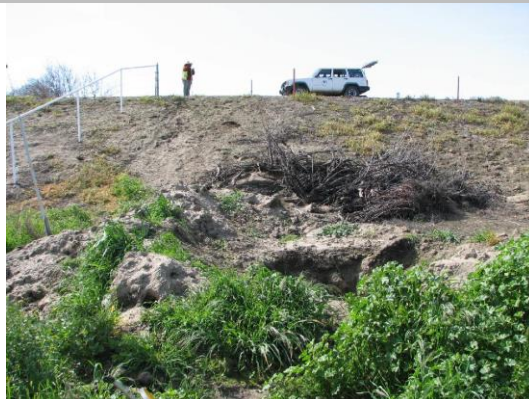
Photo 1 of 2 : UCIP_SP_2016_42878_72215.jpg

Comment Code					
Inspector Comment					
FS_ID:42878					
DS_ID:34					
EP_NO: 15117					
Repair Type: Urgent					
Crossing Status: Found					
UCIP Comments: Section of landward slope exposed--Need to contact owner to address cut on levee and determine status of crossing. Dense vegetation limits the inspector's visibility to identify signs of pipe failure (leaks) along the slope. Recommend removing vegetation along pipe alignment to conduct proper inspection of structure.					
FIELD_STRUCT_DESC: 10 inch diameter pipeline through levee. Invert of pipe is 4.26 feet below levee crown. Siphon breaker on waterward shoulder. Pump located in excess of 100 feet from the landward toe. Ramp on landward slope. (Permit No. 15117-1989)					
FS Date: 2/4/2010

View of landward side.

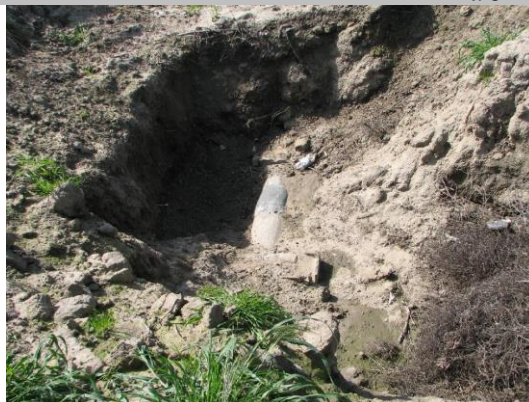
Photo 2 of 2 : UCIP_SP_2016_42878_72214.jpg

LM Start	4.95	Rating **	U	Issue No.	569 (cont)
LM End	4.95	Issue Type +	En	Location *	LS

Section of levee slope exposed on landward side.

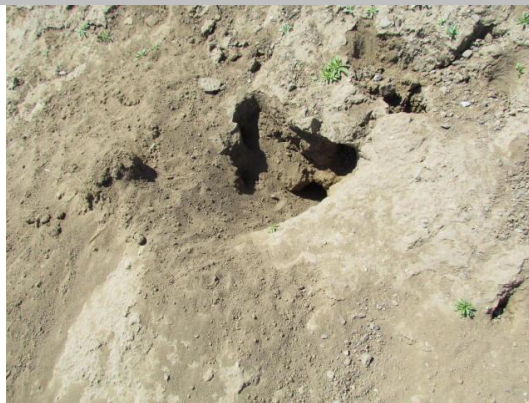
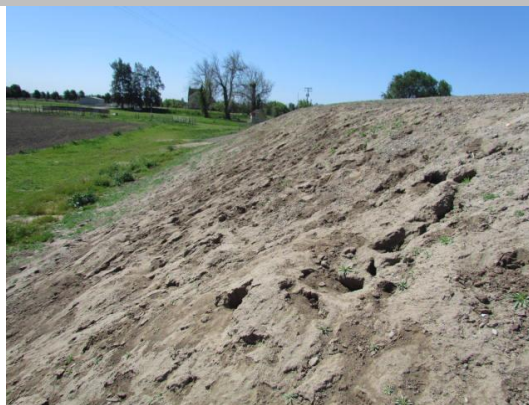
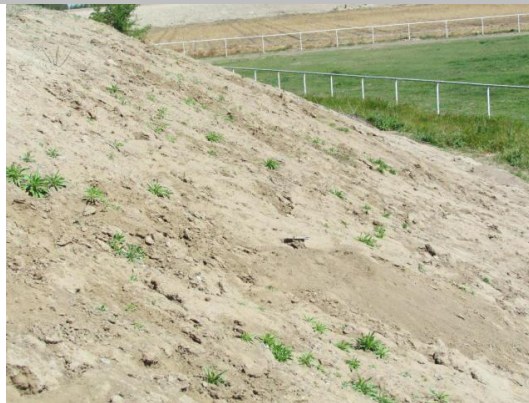
Photo 1 of 3 : SP_2016_RD0017_304_78_20160408_00196.jpg

LM Start	4.98	Rating **	U	Issue No.	78
LM End	5.12	Issue Type +	Ma	Location *	LS
Category	Earthen Levee			GPS Latitude/Longitude	
				Start	End
Item	Animal Control			37.854875 °	37.853192 °
				-121.319542 °	-121.320200 °
DWR ID	DWR_RD0017_02_s_2016_78				
Comment Code					
A1 : Exterminate rodents and backfill and compact or grout burrows.					
Inspector Comment

Looking north at rodent holes on landward slope.

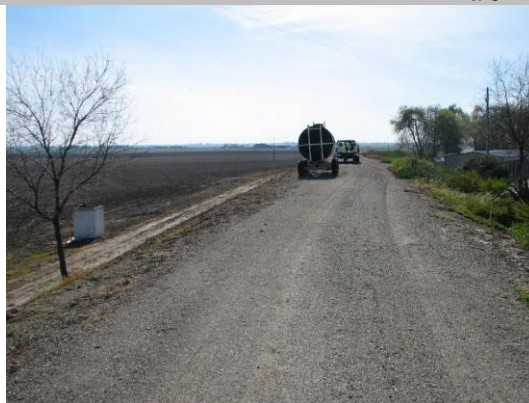
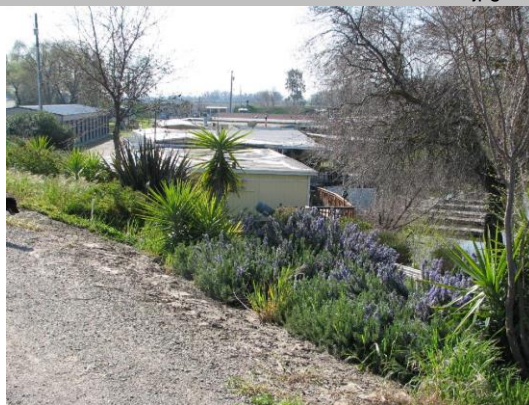
Photo 1 of 2 : UCIP_SP_2016_40669_72239.jpg

LM Start	5.41	Rating **	M	Issue No.	585
LM End	5.41	Issue Type +	En	Location *	LS
Category	Supplemental			GPS Latitude/Longitude	
				Start	End
Item	DWR UCIP Field Study			37.851319 °	37.851319 °
				-121.321336 °	-121.321336 °
DWR ID					
Comment Code					
Inspector Comment					
FS_ID:40669					
DS_ID:36					
EP_NO: 15119					
Repair Type: Non-Urgent					
Crossing Status: Found					
UCIP Comments: Need to contact owner to determine status.					
FIELD_STRUCT_DESC: 16 inch diameter pipe through levee. Invert of pipe is 5.11 feet below levee crown. Slant pump on riverbank, standpipe located 30 feet from the landward toe. Ramp on waterward slope. (Permit No. 15119-1990). This pipe was installed during the levee work approved under encroachment number 15014.					
FS Date: 2/4/2010

Overview of levee crown at crossing.

View of waterward side.

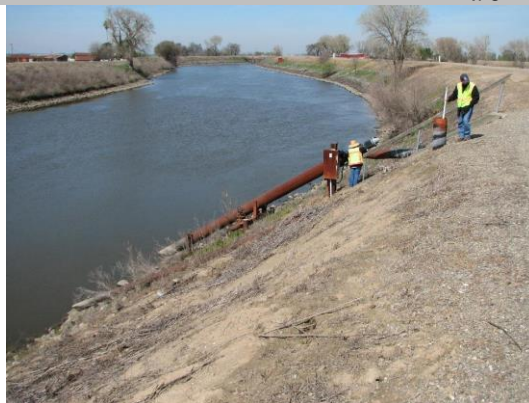
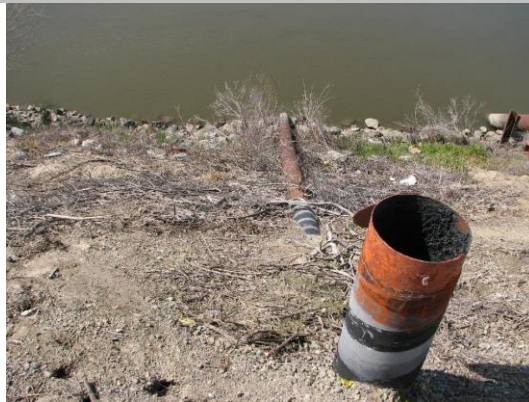
Photo 1 of 2 : UCIP_SP_2016_40672_72270.jpg

LM Start	6.14	Rating **	M	Issue No.	586
LM End	6.14	Issue Type +	En	Location *	LS
Category	Supplemental			GPS Latitude/Longitude	
				Start	End
Item	DWR UCIP Field Study			37.844392 °	37.844392 °
				-121.320753 °	-121.320753 °
DWR ID					
Comment Code					
Inspector Comment					
FS_ID:40672					
DS_ID:38					
EP_NO: 15121					
Repair Type: Non-Urgent					
Crossing Status: Found					
UCIP Comments: Pipe section at waterward toe is missing wall. Need to coordinate with owner to determine integrity of pipe section through levee. This crossing is a good candidate for video inspection to determine internal condition of pipe.					
FIELD_STRUCT_DESC: 2 of 2. 10 inch steel stormdrain through the levee 4.0-feet below crown. (Permit No. 15121-1991) This pipe was installed during the levee work approved under encroachment number 15014.					
FS Date: 2/4/2010

View of pipe section on waterward side.

View of waterward side.

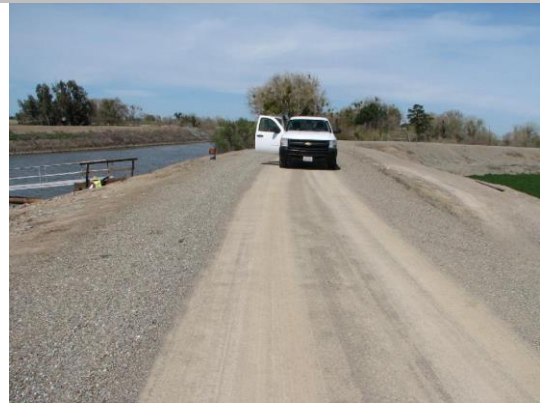
Photo 1 of 2 : UCIP_SP_2016_40677_72289.jpg

Comment Code					
Inspector Comment					
FS_ID:40677					
DS_ID:40					
EP_NO: 15123					
Repair Type: Non-Urgent					
Crossing Status: Found					
UCIP Comments: Landowner mentioned power line was stolen crossing was non-functional during inspection. Potential erosion underneath walkway--need to confirm lose soil. Need to contact owner to determine status of crossing. If crossing is no longer used need to coordinate with CVFPB for proper abandonment.					
FIELD_STRUCT_DESC: 16 inch diameter pipe through levee. Invert of pipe is 4.03 feet below the levee crown. Siphon breaker on waterward shoulder. Ramp on platform in channel, walkway from pump platform to waterward slope, standpipe located at landward berm toe. (Permit No. 15123-1989)					
FS Date: 2/4/2010

View of levee crown at crossing.

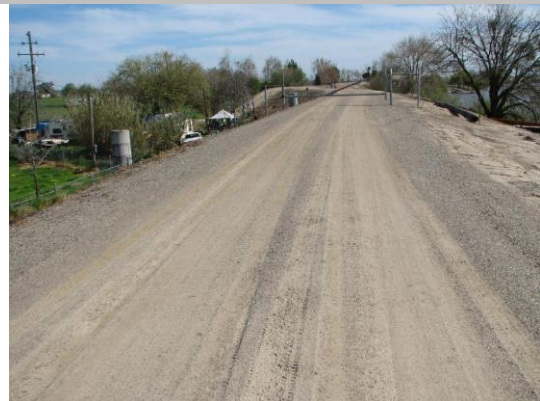
Photo 1 of 2 : UCIP_SP_2016_40679_72307.jpg

LM Start	7.17	Rating **	M	Issue No.	590
LM End	7.17	Issue Type +	En	Location *	LS
Category	Supplemental			GPS Latitude/Longitude	
				Start	End
Item	DWR UCIP Field Study			37.833426 °	37.833426 °
				-121.313023 °	-121.313023 °
DWR ID					
Comment Code					
Inspector Comment					
FS_ID:40679 DS_ID:42 EP_NO: 15077 Repair Type: Non-Urgent Crossing Status: Found UCIP Comments: Surface erosion on waterward slope. Abandoned pipe section left on waterward slope. Need to contact owner to obtain additional information about crossing. FIELD_STRUCT_DESC: 12 inch diameter irrigation pipeline through levee. Invert of pipe 3.67 feet below levee crown. Siphon breaker on landward shoulder. Pump on platform in channel, walkway from pump platform to waterward shoulder. Standpipe located 15 feet from the landward toe. (Permit No. 15077-1989) FS Date: 2/4/2010

Overview of levee crown at crossing.

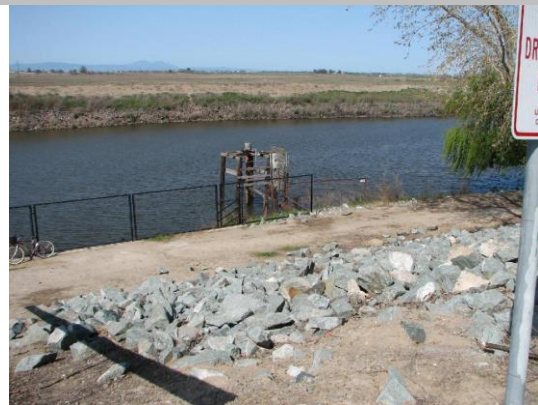
Photo 1 of 2 : UCIP_SP_2016_40681_72325.jpg

LM Start	7.43	Rating **	M	Issue No.	592
LM End	7.43	Issue Type +	En	Location *	LS
Category	Supplemental			GPS Latitude/Longitude	
				Start	End
Item	DWR UCIP Field Study			37.830158 °	37.830158 °
				-121.310915 °	-121.310915 °
DWR ID					
Comment Code					
Inspector Comment					
FS_ID:40681 DS_ID:44 EP_NO: 15079 Repair Type: Non-Urgent Crossing Status: Found UCIP Comments: If crossing is no longer in use owner will need to coordinate with DWR inspector and CVFPB to remove according to Title 23 requirements. Unable to determine if crossing is in use. FIELD_STRUCT_DESC: 14 inch pipeline through levee. Invert of pipe is 4.28 feet below levee crown. Siphon breaker on waterward shoulder. Pump on platform in channel, walkway from pump platform to the top of the riverbank, standpipe located 12 feet from landward tee. (Permit No. 15079-1990) FS Date: 2/4/2010

View of waterward side.

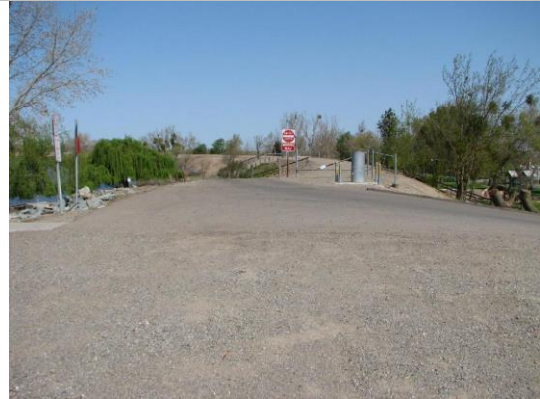
Photo 1 of 2 : UCIP_SP_2016_40682_72322.jpg

LM Start	7.44	Rating **	M	Issue No.	593
LM End	7.44	Issue Type +	En	Location *	LS
Category	Supplemental			GPS Latitude/Longitude	
				Start	End
Item	DWR UCIP Field Study			37.830115 °	37.830115 °
				-121.310908 °	-121.310908 °
DWR ID					
Comment Code					
Inspector Comment					
FS_ID:40682 DS_ID:99 EP_NO: 17643 Repair Type: Non-Urgent Crossing Status: Found UCIP Comments: Need to coordinate with owner to determine when the other 3 crossings will become online. FIELD_STRUCT_DESC: 36-inch steel lined and coated stormdrain pipe through the levee 2-feet below the crown. Concrete headwall on WS toe and a tidal flex valve on outlet of pipe. Structure was designed for 4 crossings however only 1 crossing is active (Permit No. 17643, 2005). FS Date: 2/4/2010

Overview of levee crown at crossing.

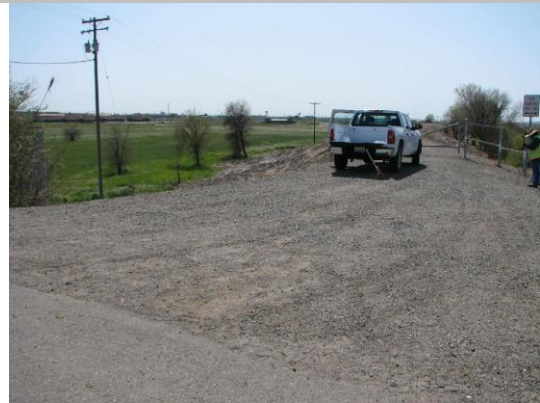
Photo 1 of 2 : UCIP_SP_2016_40683_72333.jpg

LM Start	7.45	Rating **	M	Issue No.	594
LM End	7.45	Issue Type +	En	Location *	LS
Category	Supplemental			GPS Latitude/Longitude	
				Start	End
Item	DWR UCIP Field Study			37.829922 °	37.829922 °
				-121.310865 °	-121.310865 °
DWR ID					
Comment Code					
Inspector Comment					
FS_ID:40683 DS_ID:284 EP_NO: 15079 Repair Type: Non-Urgent Crossing Status: Found UCIP Comments: Potential leak at standpipe--unable to confirm if crossing is operable. If crossing is no longer in use owner will need to coordinate with DWR inspector and CVFPB to remove according to Title 23 requirements. Unable to determine if crossing is in use. FIELD_STRUCT_DESC: 2 of 2. 10 inch pipe also referenced as 478+22, old 6 inch pipe was removed per encroachment recordation. FS Date: 2/4/2010

Overview of levee crown at crossing.

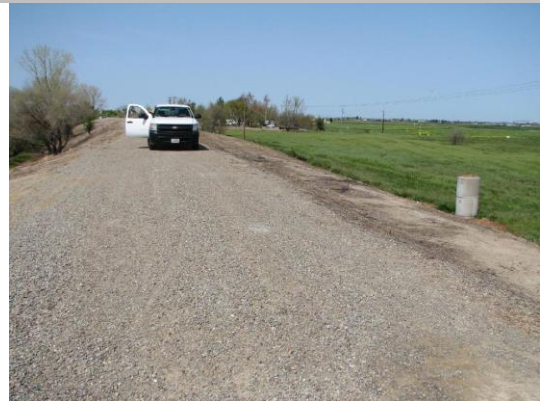
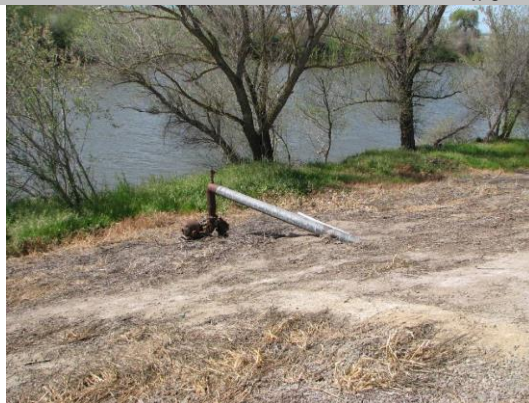
Photo 1 of 2 : UCIP_SP_2016_40684_72340.jpg

LM Start	7.57	Rating **	M	Issue No.	595
LM End	7.57	Issue Type +	En	Location *	LS
Category	Supplemental			GPS Latitude/Longitude	
				Start	End
Item	DWR UCIP Field Study			37.828258 °	37.828258 °
				-121.310003 °	-121.310003 °
DWR ID					
Comment Code					
Inspector Comment					
FS_ID:40684 DS_ID:97 EP_NO: 15080 Repair Type: Non-Urgent Crossing Status: Found UCIP Comments: Pipe appears no longer in use. If crossing is no longer in use owner will need to coordinate with DWR inspector and CVFPB to remove according to Title 23 requirements. Unable to determine if crossing is in use. FIELD_STRUCT_DESC: 6 inch steel irrigation pipe through the levee at 4.43-feet below crown. Pump on WS slope, siphon breaker on WS shoulder, and standpipe on LS toe (Permit No. 15080-1989). FS Date: 2/4/2010

Overview of levee crown at crossing.

View of waterward side.

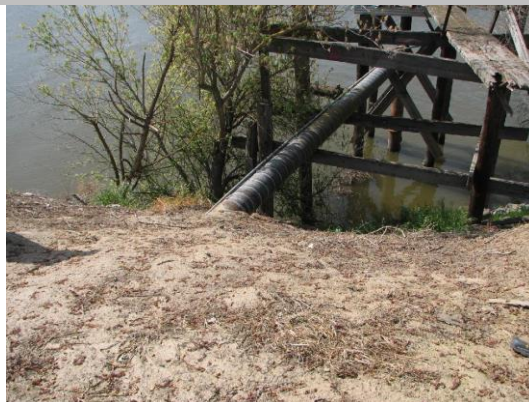
Photo 1 of 2 : UCIP_SP_2016_40685_72351.jpg

LM Start	7.71	Rating **	M	Issue No.	596
LM End	7.71	Issue Type +	En	Location *	LS
Category	Supplemental			GPS Latitude/Longitude	
				Start	End
Item	DWR UCIP Field Study			37.826333 °	37.826333 °
				-121.309495 °	-121.309495 °
DWR ID					
Comment Code					
Inspector Comment					
FS_ID:40685 DS_ID:98 EP_NO: 15081 Repair Type: Non-Urgent Crossing Status: Found UCIP Comments: Erosion present on waterward toe underneath piles. Need to coordinate with owner to address issue on waterward side and to determine status of crossing. FIELD_STRUCT_DESC: 16 inch diameter asphalt coated and wrapped steel irrigaiton pipe through the levee 2.6-feet below the crown. Siphon breaker located on landward side. Stand pipe located at landward toe. Pump on Platform at WS toe Permit No. 15081, 1989. FS Date: 2/4/2010

Overview of levee crown at pipe crossing.

Pipe daylight on waterward side.

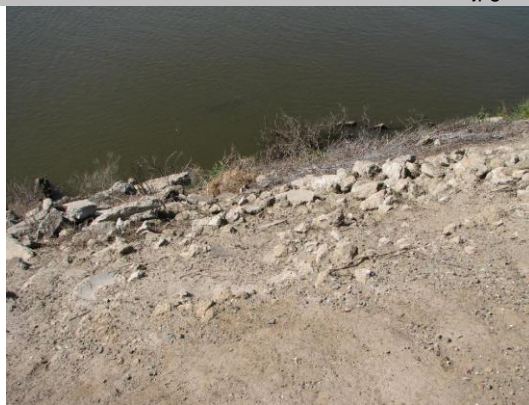
Photo 2 of 2 : UCIP_SP_2016_40686_72352.jpg

LM Start	7.73	Rating **	M	Issue No.	597
LM End	7.73	Issue Type +	En	Location *	LS
Category	Supplemental			GPS Latitude/Longitude	
				Start	End
Item	DWR UCIP Field Study			37.826031 °	37.826031 °
				-121.309569 °	-121.309569 °
DWR ID					
Comment Code					
Inspector Comment					
FS_ID:40686 DS_ID:804 EP_NO: N/A Repair Type: Non-Urgent Crossing Status: Indicator Found UCIP Comments: Unable to find any appurtenances need to coordinate with owner to obtain additional informaiton about crossing. Standpipe appears abandoned. If crossing is no longer in use owner will need to coordinate with DWR inspector and CVFPB to remove according to Title 23 requirements. Unable to determine if crossing is in use. FIELD_STRUCT_DESC: Standpipe located on levee crown. FS Date: 2/4/2010

View of waterward side.

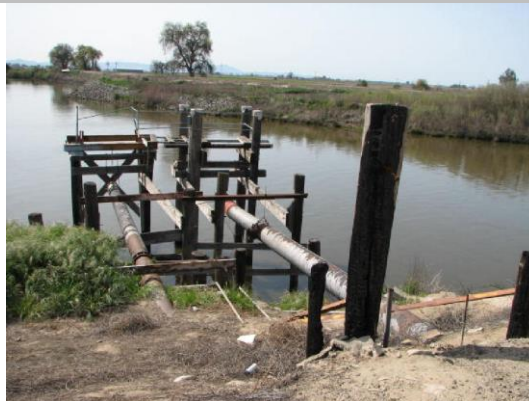
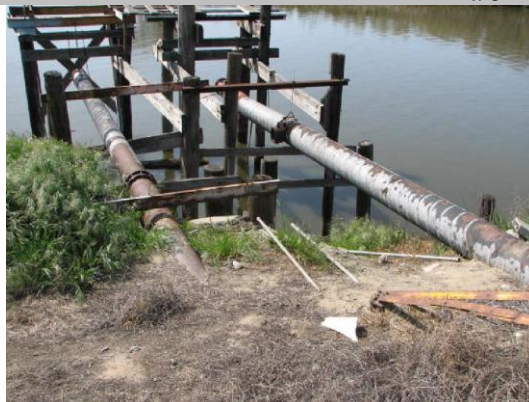
Photo 1 of 2 : UCIP_SP_2016_40687_72357.jpg

Comment Code					
Inspector Comment					
FS_ID:40687 DS_ID:100 EP_NO: 15082 Repair Type: Non-Urgent Crossing Status: Found UCIP Comments: Pumps were removed and no power connection visible. Crossing appears abandoned. If crossing is no longer in use owner will need to coordinate with DWR inspector and CVFPB to remove according to Title 23 requirements. Unable to determine if crossing is in use. FIELD_STRUCT_DESC: 1 of 2. 20 inch asphalt coated and wrapped steel irrigation pipe through levee 2.1-feet below the crown. Pump missing from platform on waterward side. Siphon breaker inside 24-inch CMP riser on LS shoulder (Permit No. 15082, 1982). FS Date: 2/4/2010

View of waterward side.

View of waterward side--no pumps present anymore.

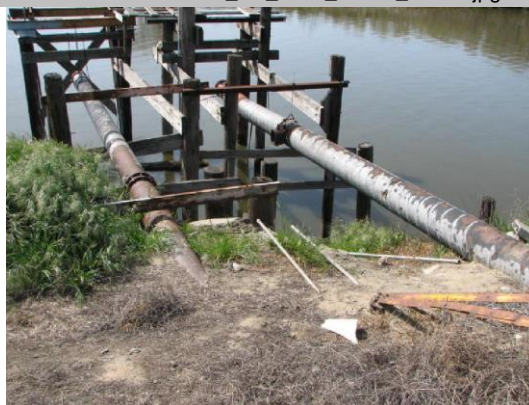
Photo 1 of 2 : UCIP_SP_2016_40688_72361.jpg

FS_ID:40688
DS_ID:288
EP_NO: 15082
Repair Type: Non-Urgent
Crossing Status: Found
UCIP Comments: Pump was removed and no power connection visible. Crossing appears abandoned. If crossing is no longer in use owner will need to coordinate with DWR inspector and CVFPB to remove according to Title 23 requirements. Unable to determine if crossing is in use.
FIELD_STRUCT_DESC: 2 of 2. 16- inch asphalt coated and wrapped steel irrigation pipe through levee 2.6-feet below the crown. Pump missing from platform on waterward side. Siphon breaker inside 24-inch CMP riser on LS shoulder. 1.5-inch galvanized iron electrical conduit at same location (Permit No. 15082, 1982).
FS Date: 2/4/2010

View of pipe on waterward side.

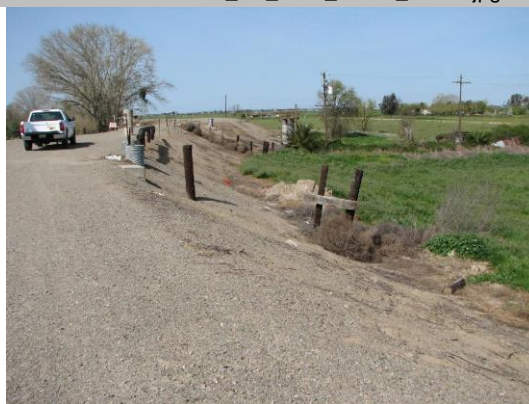
Photo 2 of 2 : UCIP_SP_2016_40688_72360.jpg

View of landward side.

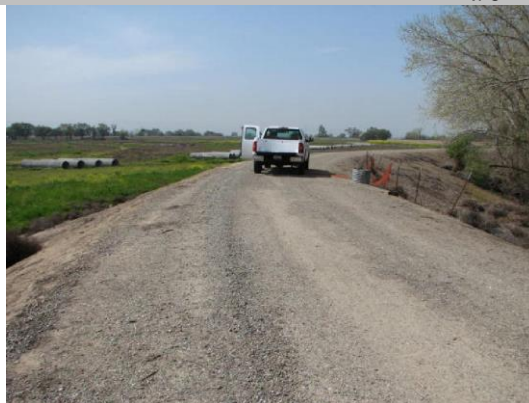
Photo 1 of 2 : UCIP_SP_2016_40689_72367.jpg

LM Start	7.89	Rating **	M	Issue No.	600
LM End	7.89	Issue Type +	En	Location *	LS
Category	Supplemental			GPS Latitude/Longitude	
				Start	End
Item	DWR UCIP Field Study			37.823987 °	37.823987 °
				-121.309841 °	-121.309841 °
DWR ID					
Comment Code					
Inspector Comment					
FS_ID:40689					
DS_ID:805					
EP_NO: N/A					
Repair Type: Non-Urgent					
Crossing Status: Indicator Found					
UCIP Comments: Only siphon breakers were found on landward shoulder no other appurtenances were found. If crossing is no longer in use owner will need to coordinate with DWR inspector and CVFPB to remove according to Title 23 requirements. Unable to determine if crossing is in use.					
FIELD_STRUCT_DESC: Siphon breaker located on landward shoulder.					
FS Date: 2/4/2010

View of levee crown at crossing.

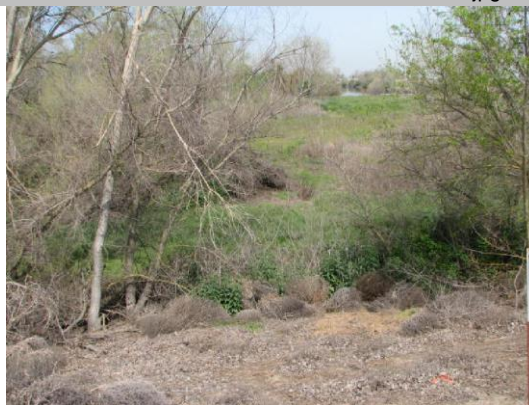
Photo 2 of 2 : UCIP_SP_2016_40689_72366.jpg

View of landward side.

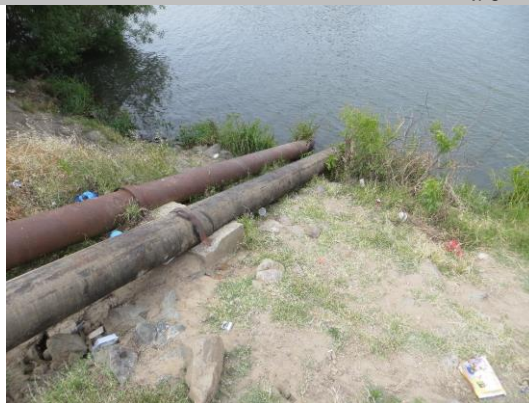
Photo 2 of 2 : UCIP_SP_2016_46008_74473.jpg

Comment Code					
Inspector Comment					
FS_ID:46008 DS_ID:285 EP_NO: 15083 Repair Type: Urgent Crossing Status: Found UCIP Comments: 05/21/2015 Pipe is still in same condition. Need to contact KSN, LMA engineering firm, to determine update on crossing.02/04/2010 Pipe wall has corroded through--wall missing from pipe section located on waterward side. Recommend investigating the pipe integrity through levee section. Damage to pipe has eroded the levee slope on waterward side. Recommend LMA superintendent contact owner to stop using crossing and coordinate with CVFPB to address pipe leak. Owner will need to coordinate with DWR inspector and CVFPB. FIELD_STRUCT_DESC: 2 of 2. 12-inch irrigation pipe through levee. Invert of pipe is 3.69 feet below crown. Siphon breaker on landward shoulder. Pump in irrigation ditch 50 feet from landward tee. (Permit No. 15083-1989) FS Date: 5/21/2015

(2015) View of second pipe not replaced.

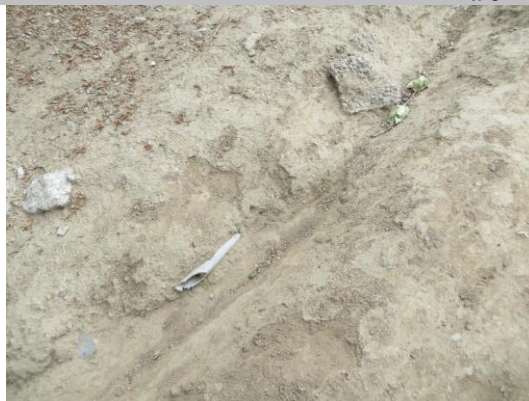
Photo 1 of 2 : UCIP_SP_2016_45453_74112.jpg

Comment Code					
Inspector Comment					
FS_ID:45453 DS_ID:48 EP_NO: 15084 Repair Type: Non-Urgent Crossing Status: Indicator Found UCIP Comments: Need to contact owner to determine disposition of pipe. No record of removal has been found and status of crossing needs to be determined. FIELD_STRUCT_DESC: 8 inch diameter pipe through levee. Invert of pipe is 3.47 feet below levee crown. (Siphon breaker on landward shoulder. Slant pump on waterward slope, concrete stairway from pump to waterward shoulder, standpipe located 20 feet from the landward toe): Not found. Only indicator is a 1.5-inch PVC electrical conduit visible on WS slope 6-feet below the crown. (Permit No. 15084-1989) FS Date: 5/21/2015

Electrical conduit only appurtenance found on WS slope.

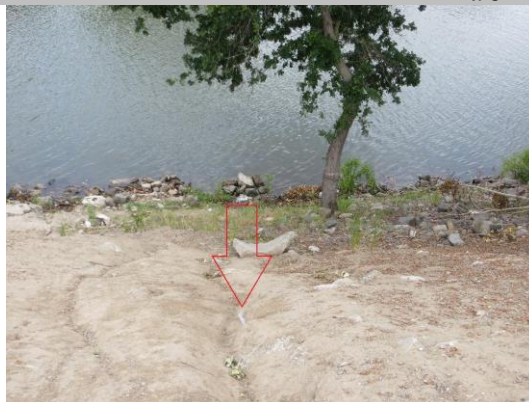
Photo 2 of 2 : UCIP_SP_2016_45453_74113.jpg

1.5-inch electrical conduit only appurtenance still visible on WS slope.
